A Summary of a NIOSH fire fighter fatality investigation

Volunteer Fire Fighter (Lieutenant) Killed and One Fire Fighter Injured During Mobile Home Fire— Pennsylvania

Fatality Assessment and Control Evaluation Investigative Report #F2001-04

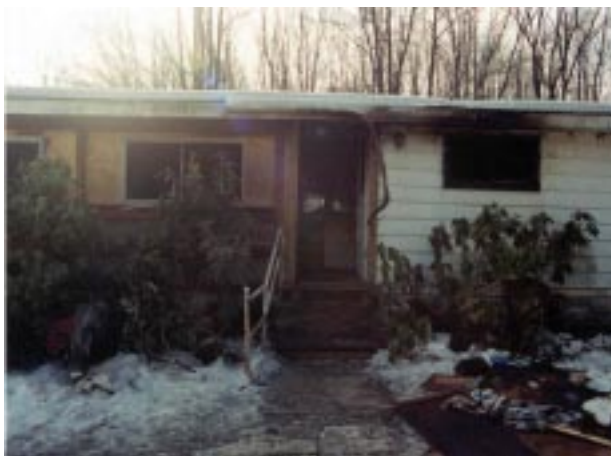
Mobile Home Involved in Fire

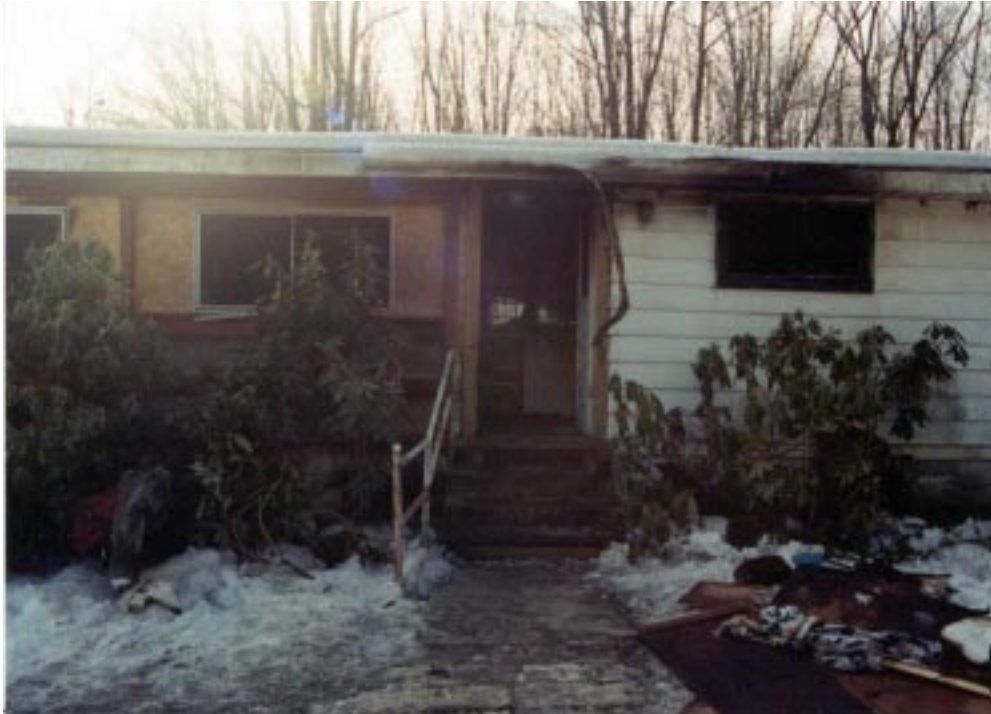
In the interim, the First Assistant Chief and a fire fighter from Engine 19 pulled a 1 ¾-inch line to the front door (first floor, Side 1) entrance of the mobile home and entered (see Figure 1 and Photo 1). After entering, they moved left along a wall and discovered they were in an enclosed porch on the outside of the mobile home (see Photo 2), but could see fire through the windows in the interior of the home. The First Assistant Chief gave the nozzle to the fire fighter and an unidentified fire fighter, and he began breaking windows along the outside wall of the mobile home. The two fire fighters hit the fire through the windows, but had little effect on the fire. The two fire fighters then proceeded through another door off the porch area into the interior (addition) of the mobile home to attack the fire (see Photo 3). At that time, the First Assistant Chief's low-air alarm sounded on his self-contained breathing apparatus (SCBA), and he turned over interior command to the 2nd Assistant Chief, who had arrived earlier in his POV. The First Assistant Chief changed his air bottle, then pulled a 1 ¾-inch line off the front of Engine 19 to Side 3 and began hitting the fire through the doorway (Side 3, first floor) into the corner bedroom (see Photo 4).

Photo 1. Front Door Entrance to Mobile Home (Side 1)

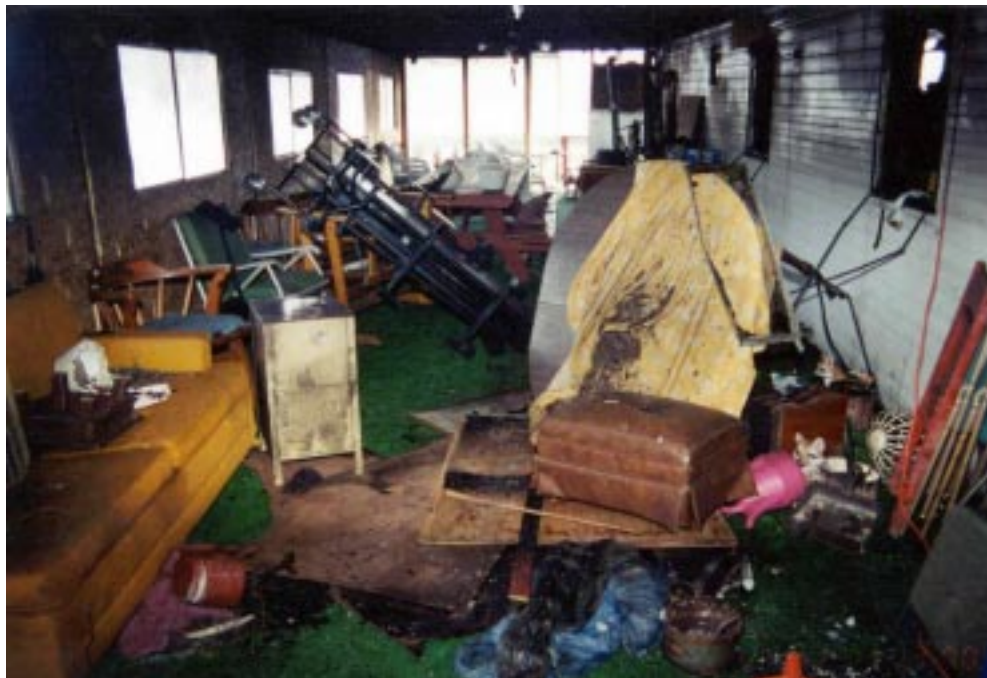
Photo 2. Enclosed Porch Attached to Mobile Home

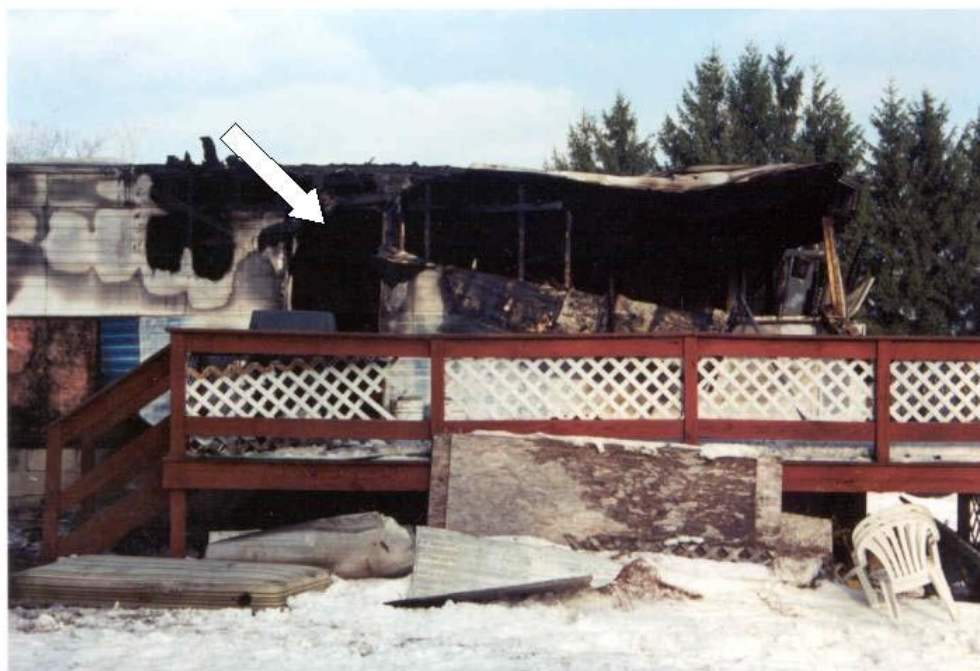
Photo 4. Doorway Into Corner Bedroom (Side 3)

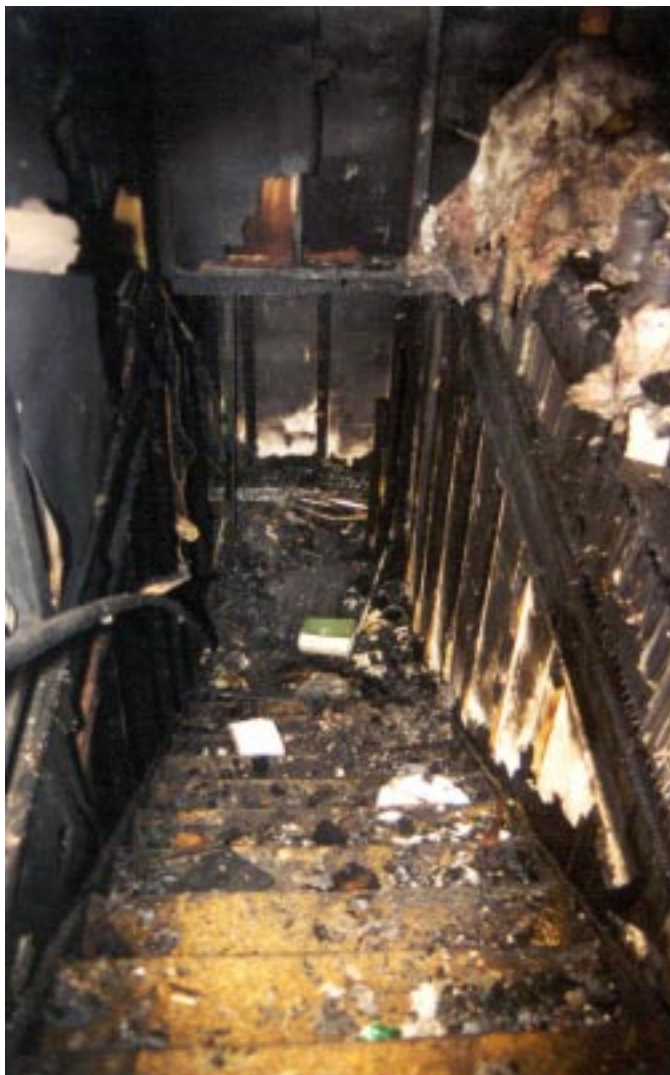
Photo 7. Stairway Connecting Addition to Basement

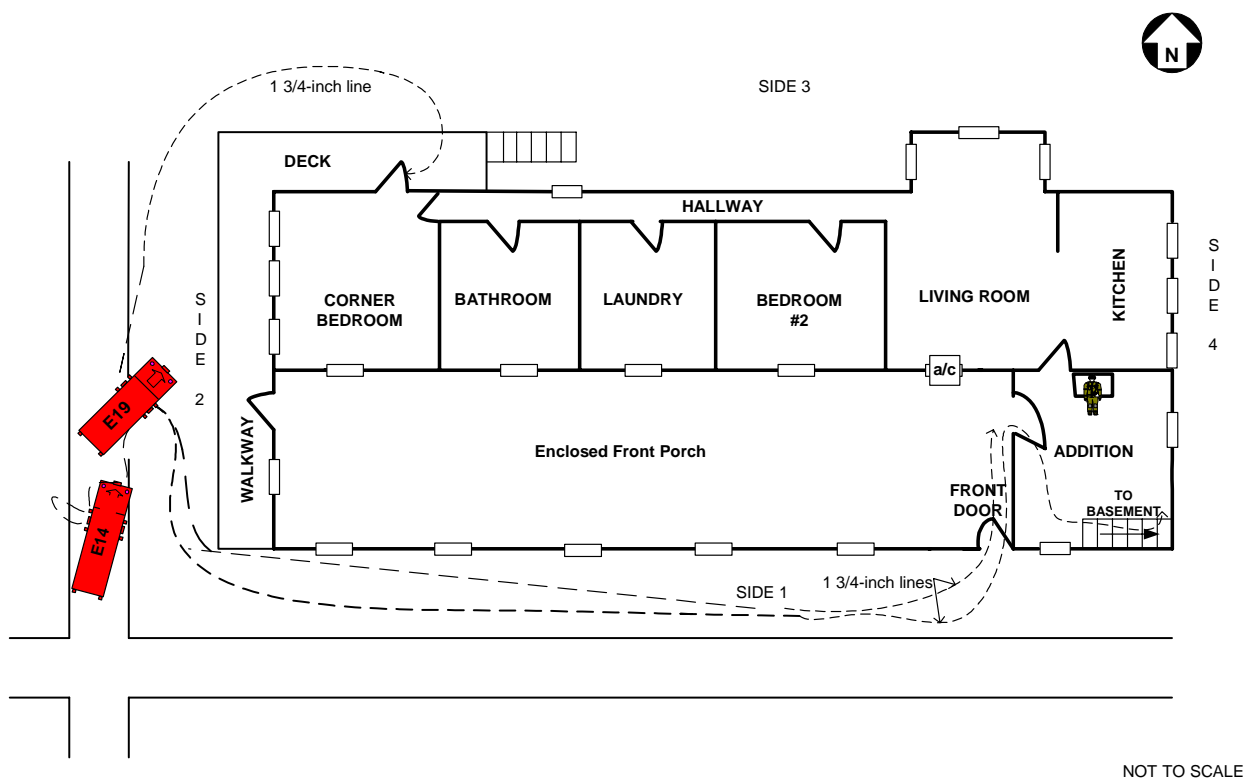
Figure 1. Mobile Home, First Floor Layout

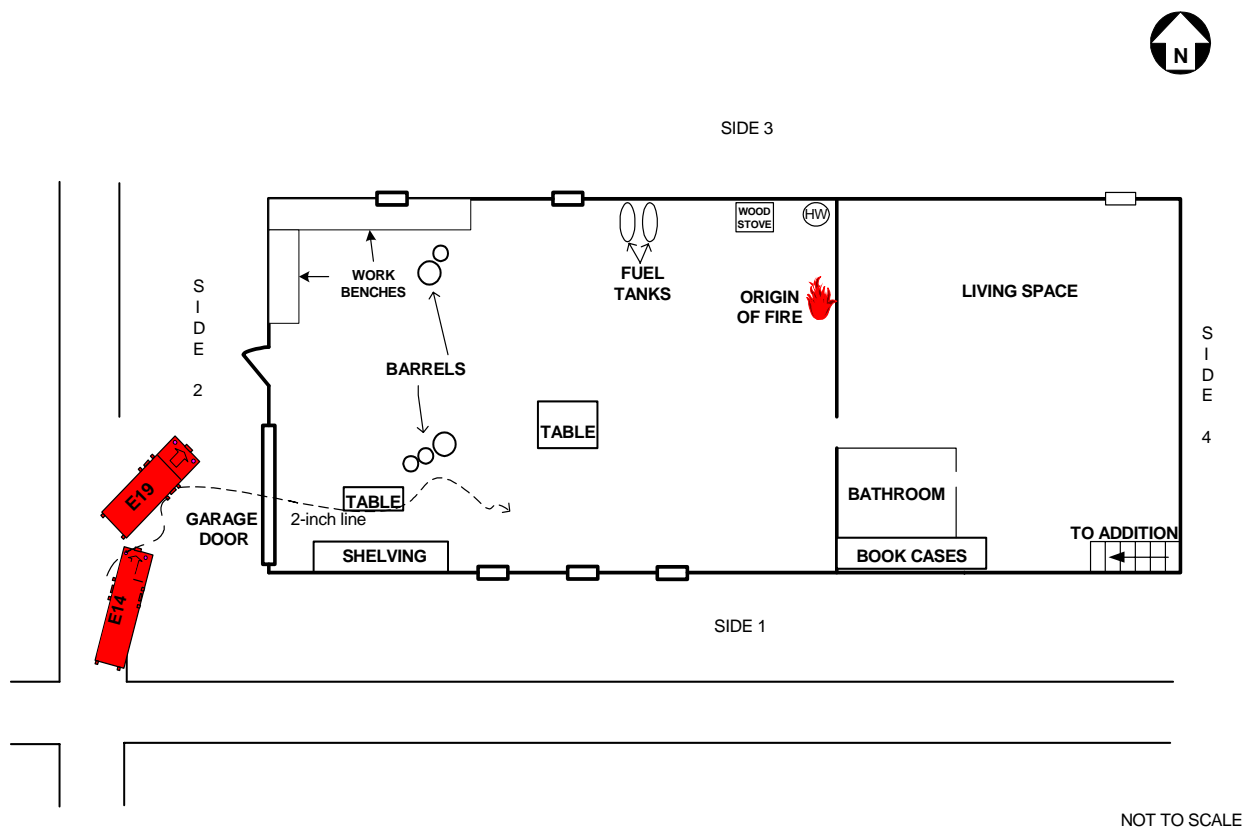
Figure 2. Mobile Home, Basement Floor Layout
